Environmental Stewardship Assessment Parsonage, First Church, Sterling, MA

48 Main Street, Sterling

This is a summary of observations and recommendations of a site visit on February 9, 2023 by Jim Nail and Bill Schroeder for MassIPL. The visit was prompted by the ESA for the church.

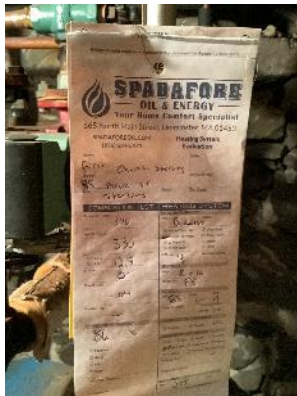
To operate efficiently, boilers should be cleaned and tuned annually. The service tag hanging on the boiler indicates this maintenance is done regularly (see Photo 2)

#2 - The service tag on the boiler shows it received regular maintenance. Good work!

Keep up the good work!

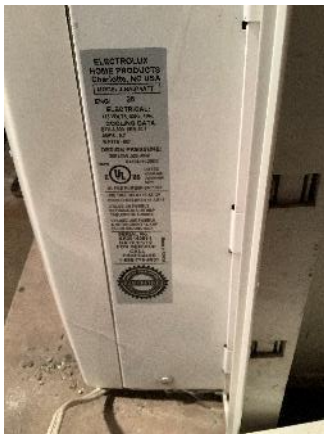
While there is no central air conditioning, there was a window air conditioner stored in the basement (see Photo 3).

#3 - Window air conditioners are used in the summer and stored in the basement.

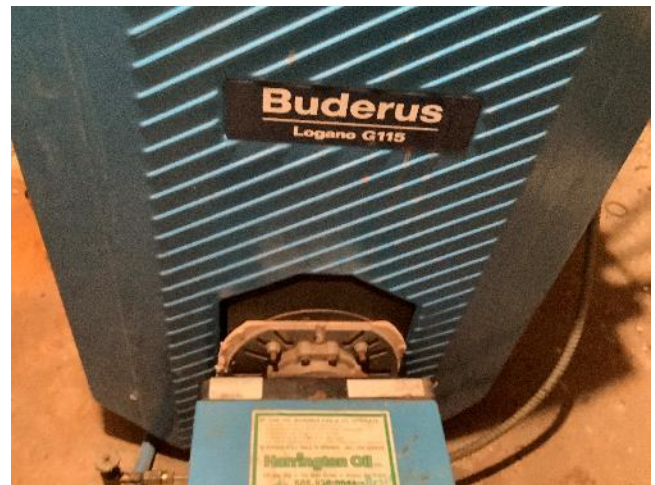
- Boilers — The Parsonage has an oil-fired Buderus boiler that appears to be in good condition (see Photo 4); based on the serial number, it appears that this boiler was

#4 - The oil-fired Buderus boiler is about 85% efficient.

As long as the boiler continues to operate with no problems, there is no urgent need to replace it and priority should be given to the work recommended in the ESA for the church. Install pipe insulation of the appropriate diameter at the local home center or hardware store, cut it to length as needed, and wrap it around exposed pipes. This is an easy, inexpensive DIY project.

In any case, we recommend you replace the boiler and hot water heater by around 2030, in line with the state goal to reduce carbon emissions 50% by then.

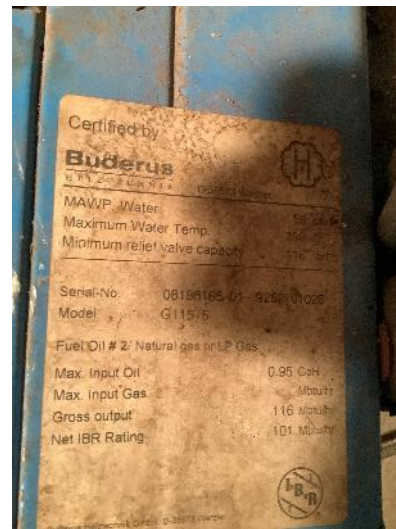
manufactured in 2009 (see Photo 5). Boilers have an expected useful life of 25 – 30 years so it is about halfway through its life.

#5 - The serial number of the hot water heater suggests the boiler was manufactured in 2009.

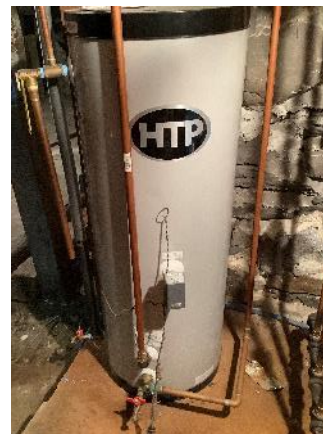
- Domestic Hot Water — Hot water is supplied by an indirect tank paired with the boiler (see Photo 6). This is a relatively efficient way to heat water but requires that the boiler remain on all year round. Replacing it with a hybrid heat pump model would allow you to turn the boiler off from about May 1 – October 1 and reduce your oil consumption by likely 75 – 100 gallons. At oil's current \$4.00 per gallon rate and your electricity rate of \$.155 per kwh, you might save as much as \$150 - \$250 per year.

Many of the pipes, especially from the boiler to the hot water heater, are uninsulated. Standard baseboard radiators are located in most rooms.

#6 - The hot water tank is an indirect model, circulating hot water from the boiler through a heat exchanger. Note the uninsulated pipes.

Consider replacing the hot water heater with a hybrid heat pump model. Check if Sterling Municipal Light Department provides a rebate. You will need a 220 volt electric circuit and your electrician would need to determine if you have capacity and space in your electric panel.

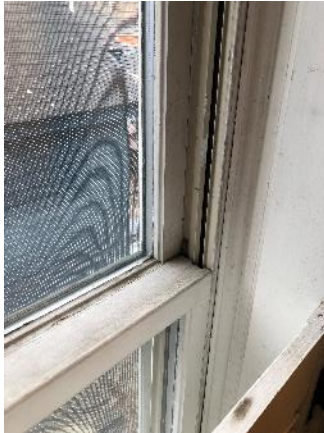
As mentioned, replacement windows have been installed (see Photo 7). Doors appear to be adequate and fit well in their frames and have storm doors.

#7 – The Parsonage windows are double pane replacements, believed to have been installed as part of the 2014 renovation.

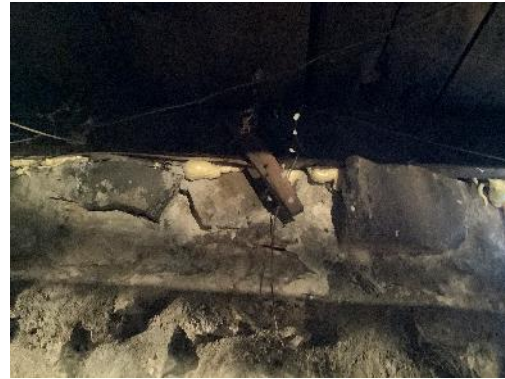
In the basement, some air sealing was done around the foundation (see Photo 10). However, there is no insulation between the floor joists (see Photo 11), thus there is no thermal boundary. Typically 10 – 20% of the heat loss a home experiences is through the foundation, so installing insulation between the floor joists is a good potential project. The only reason not to is if there is enough residual heat from the boiler that the basement remains fairly warm; in this case, that heat will slow heat loss from the living space.

#10 – Spray foam has been applied to seal areas between the stone foundation and the wooden floor framing members. This reduces cold air infiltration – as well as mice and insect intrusions!

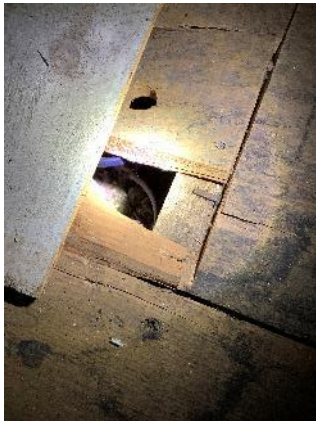
When additional insulation was installed, the thermal boundary was established at the ceiling of the second floor, which is typical. Blown cellulose was installed by drilling holes in some of the floorboards of the attic (see Photo 8). Thus there is no insulation (and no need for it) between the roof rafters. The attic door is insulated with 2 inches of extruded polystyrene foam (see Photo 9), continuing the thermal boundary between the attic and the living space.

#8 – Blown in cellulose insulation has been added to the attic floor, as shown by the hole drilled into the floor board and the material seen in the gap between the boards.

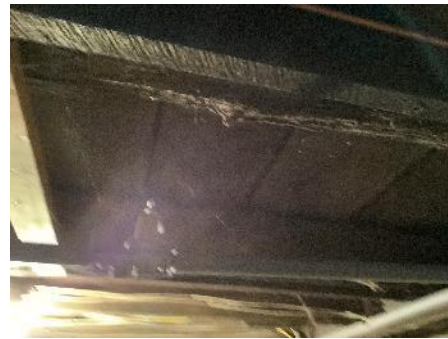
#11 – There is no insulation between the floor joists in the basement. Mineral wool batts would be a good solution.

To insulate between the basement floor joists, mineral wool has a couple of advantages: it is highly resistant to fire, it does not absorb water or humidity, deters mice, and batts are easier to work with and neater than blown materials. It is a fairly small area so could even be done by parish members in a couple of hours.

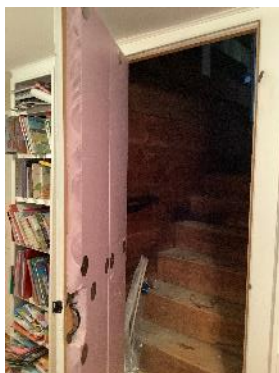
#9 – The door to the attic is well insulated, continuing the thermal boundary between the living space and the attic.

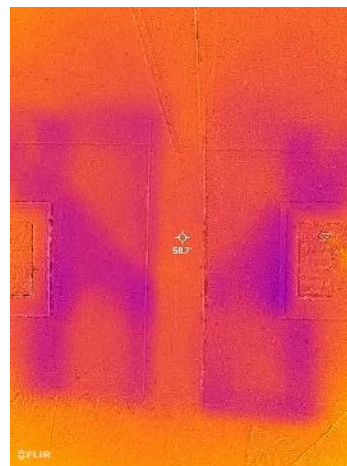
- Using a Flir infrared camera attachment to an iPad, the areas between the studs appear colder, indicating little insulation (see Photo 12).
- In the rear bedroom, insulation above the ceiling appears to be adequate but the area where the wall meets the ceiling shows significant cold air (see Photo 13). This is typical and is solved by air sealing the framing component known as the “top plate” to the drywall.

#12 – This infrared photo of a wall shows cold areas (purple) suggesting there is little insulation in the walls. Blowing in cellulose from the exterior is a typical way to address this situation.

Call Sterling Municipal Light Department to schedule an energy assessment and draw their attention to the insulation and air sealing issues noted above <https://nextzero.org/sterling/energy-audits/>.

Blowing insulation into the exterior walls may be possible. Typically, a few clapboards are removed to allow a 2 – 3 inch hole to be drilled through the sheathing at intervals to allow a hose to be inserted to install the insulation; the holes are then patched and the clapboard reinstalled. If you plan to paint the Parsonage, consider doing this project prior to painting.

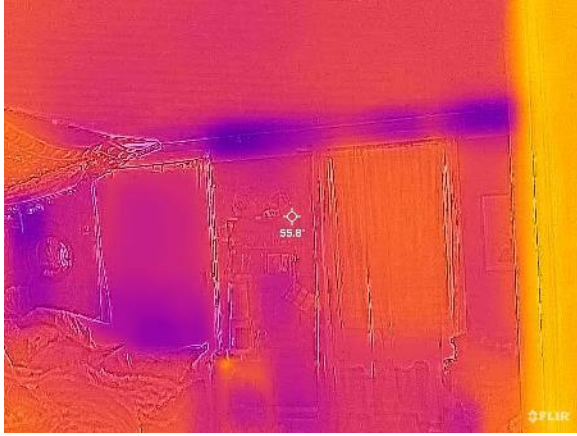
#13 - In the rear bedroom (believed to be a converted garage), the dark area where the wall meets the ceiling indicates air leaking around the framing member called the "top plate". Air sealing this would reduce this heat loss
